Comboni Hospital Sakopage

Inspection of the electrical Installation:

Date of Inspection: 11/04/2016

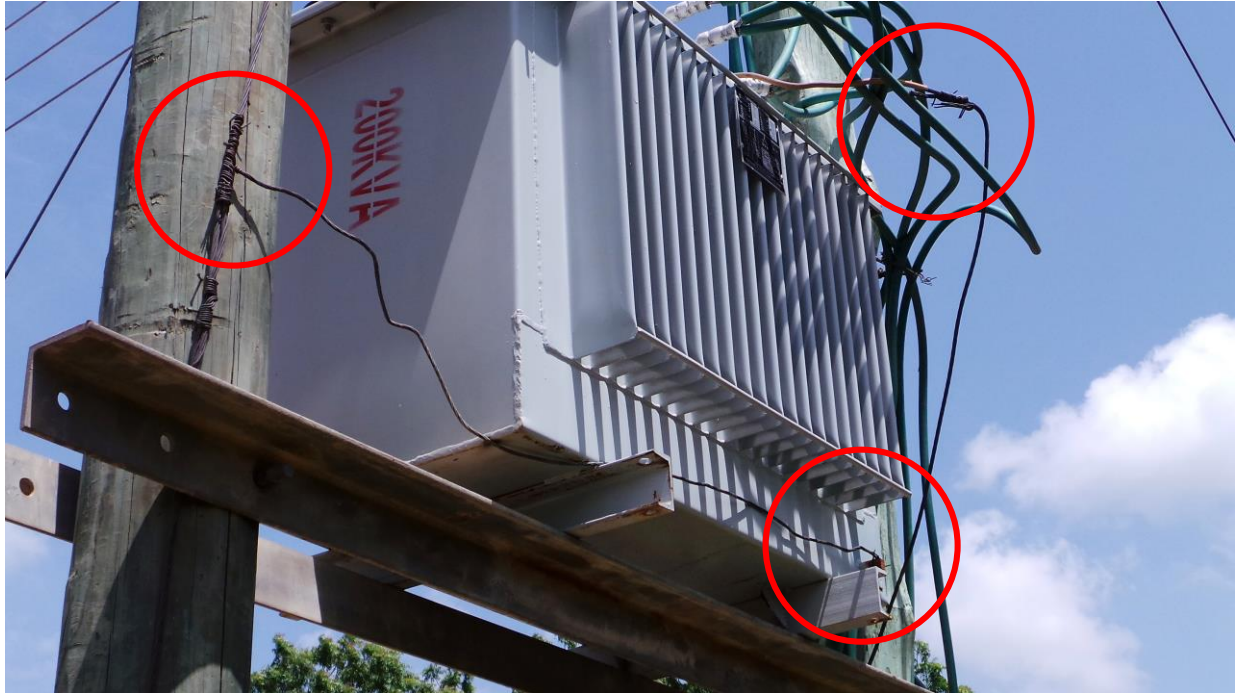
01 ECG Æ Feedline, Overhead Transformer:

01.01 The Voltage at the actual step of the Transformer is too high.....! High voltage will affect electrical and electronic systems all over the Hospital.

L 1	ó	N	= 252 V	116 Amps.
L 2	ó	N	= 250 V	92 Amps
L 3	ó	N	= 250 V	123 Amps

Grounding Resistance: 3.3 Ω

○ Twisted wire, needs good cable connectors

The Voltage is too high. The ECG- Transformer must be stepped down to a tension of max. 235 V.

The Grounding Resistance must be below 1 Ω.

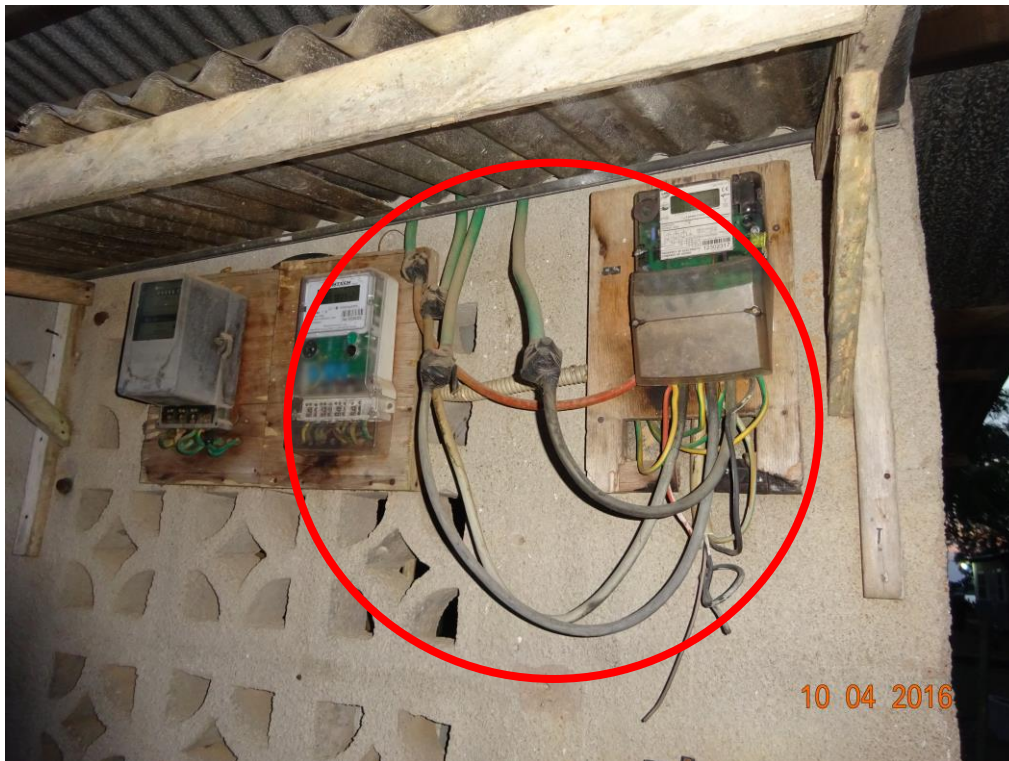
02 ECG- feeding Powerhouse:

02.01 The ECG- Grid main feeding line must be connected to an Incoming Fuse or switch before the connection to the ECG- meter.

02.02 Instead of single lead wires a cable with 4 x 150 mm² would be requested.

02.03 In case of a fault, the incoming line must be able to switch off.

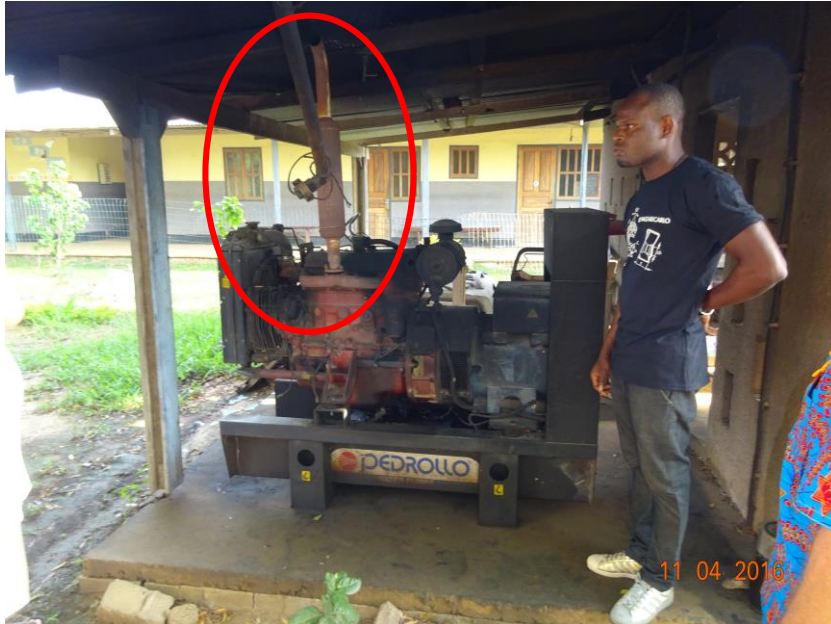
02.05 The generator supply to the Theatre and the Dental clinic is in a very bad condition and needs a general replacement. (new cable)

02.06 Oil leakages, voltage fluctuations,

02.07 Exhaust must be guided outside the roof

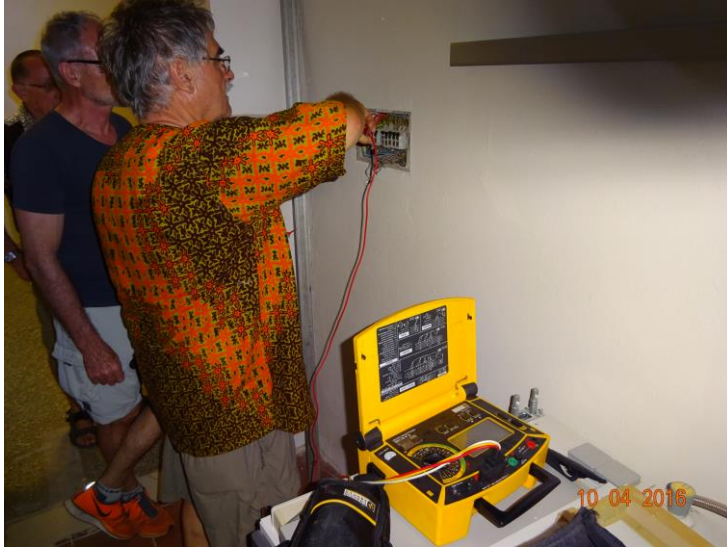
03 Dental Clinic

- 03.01 All fuse boards need general overhauls. All wire connecting points must be divided to separate wire connector. (see sample GHST)
- 03.02 Some of the fuse groups are over fused and provide no safety. (Danger of fire) (1.5 mm² max. fuse 10 Amps, 2,5 mm² max. 16 Amps., 4 mm² max. 20 Amps., 6 mm² max. 25 Amps.....)
- 03.03 The main supply cable from the power house to the dental clinic must be replaced. (5 x 16 mm²)
- 03.04 All wall sockets must be connected with a separate lead (yellow- green) to the ground.
- 03.05 All metallic table and others must be connected to the ground. (min. size cable 2.5 mm² yellow- green)

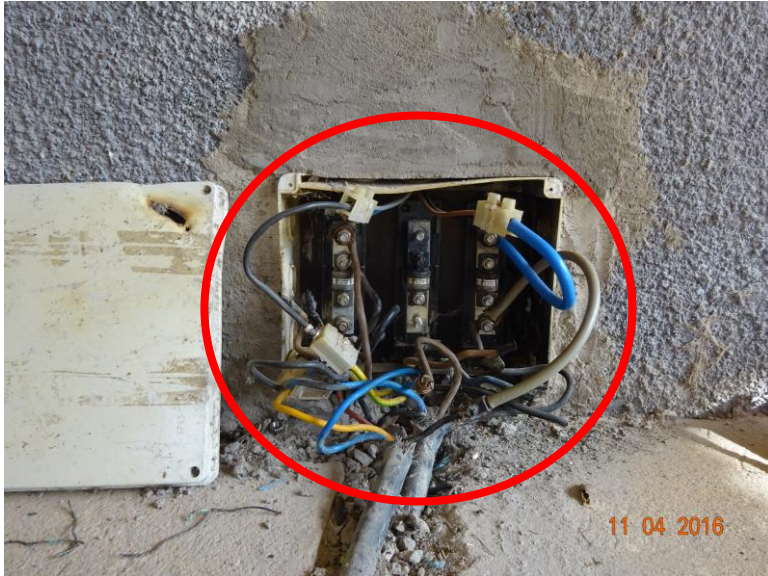
04 Theatre

- 04.01 The whole electrical installation at the theatre is in a very bad condition and unsafe.
- 04.02 The main supply line from Powerhouse must be replaced. Size 5 x 16 mm² .
- 04.03 The junction box for the incoming cable is located on a dangerous place. The box must be fixed 1.5 m above the floor
Open connections, twisted cable connections, no way to identify the leads, not covered...

04.04 All fuse boxes must be done as sample GSHT to prevent electrical shocks and fire.

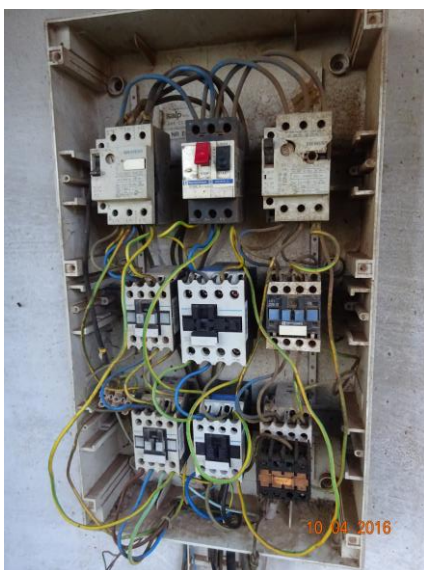
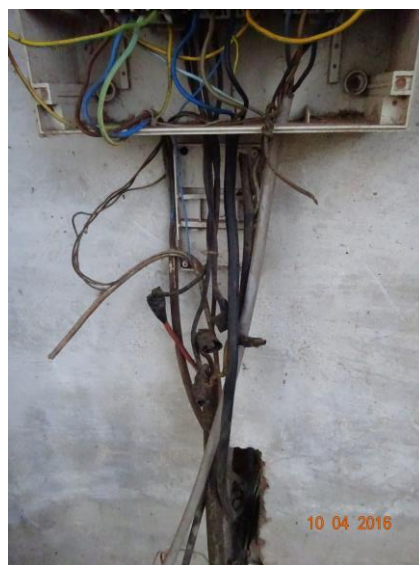
05 Hospital Main water supply

- 05.01 The Electrical connection is faulty. A new cable from the power house to the water pumping station must be installed, size 5 x 10 mm² .
- 05.02 The pump control board is in a horrible condition. Wrong coloured and flying wires, twisted wire connection, no adequate fuse, no RCD...!!
- 05.03 The pump control board is open and is affected from dust and humidity, the installation must be placed in a dust- and waterproof housing.
- 05.04 An useful Water filtering system should be installed to prevent clogging the pipes.

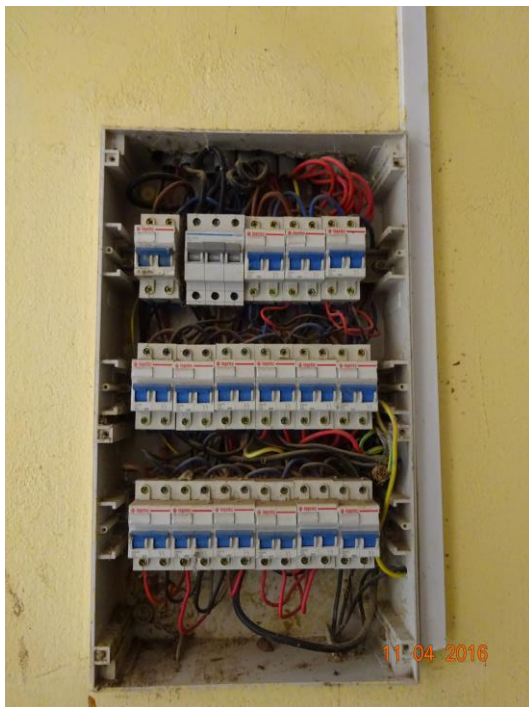
06 Administration Block

- 06.01 The ECG incoming line is connected direct to the fuse board. A main control switch must be installed. To prevent and protect all electronic devices from overvoltage and lightning a solid grounded surge must be installed.
- 06.02 Most of the electrical circuits are over fused. Replace the wrong fuses according the outgoing size of the wires. (see 03.02) .
- 06.03 To hook the administration block to the emergency power supply, a cable from Powerhouse should be laid. Size 5 x 16 mm² .
- 06.04 All wall sockets must be checked. Most of them are not connected to the Ground.

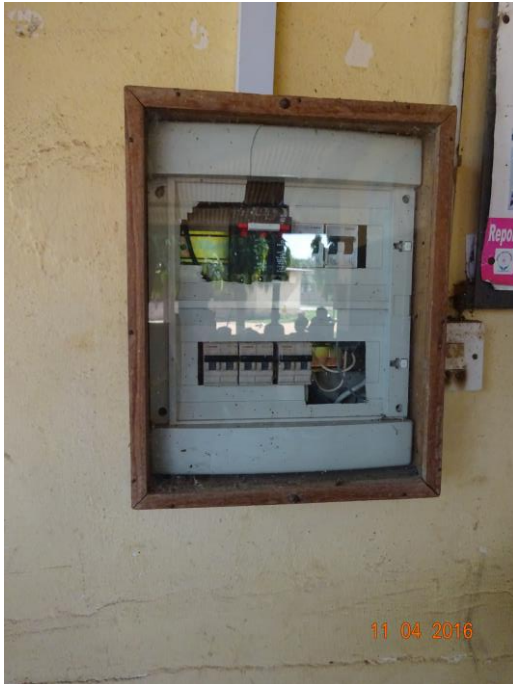
07 Maternity

07.01 The fuse board must be done like the GSHT – sample. Some of the outgoing lines are over fused. See 03.02

07.02 The fuse board cover must be fixed proper to prevent dust and insects to enter.
