Comboni Hospital Sakopage

Inspection of the electrical Installation:

Inspection Report:

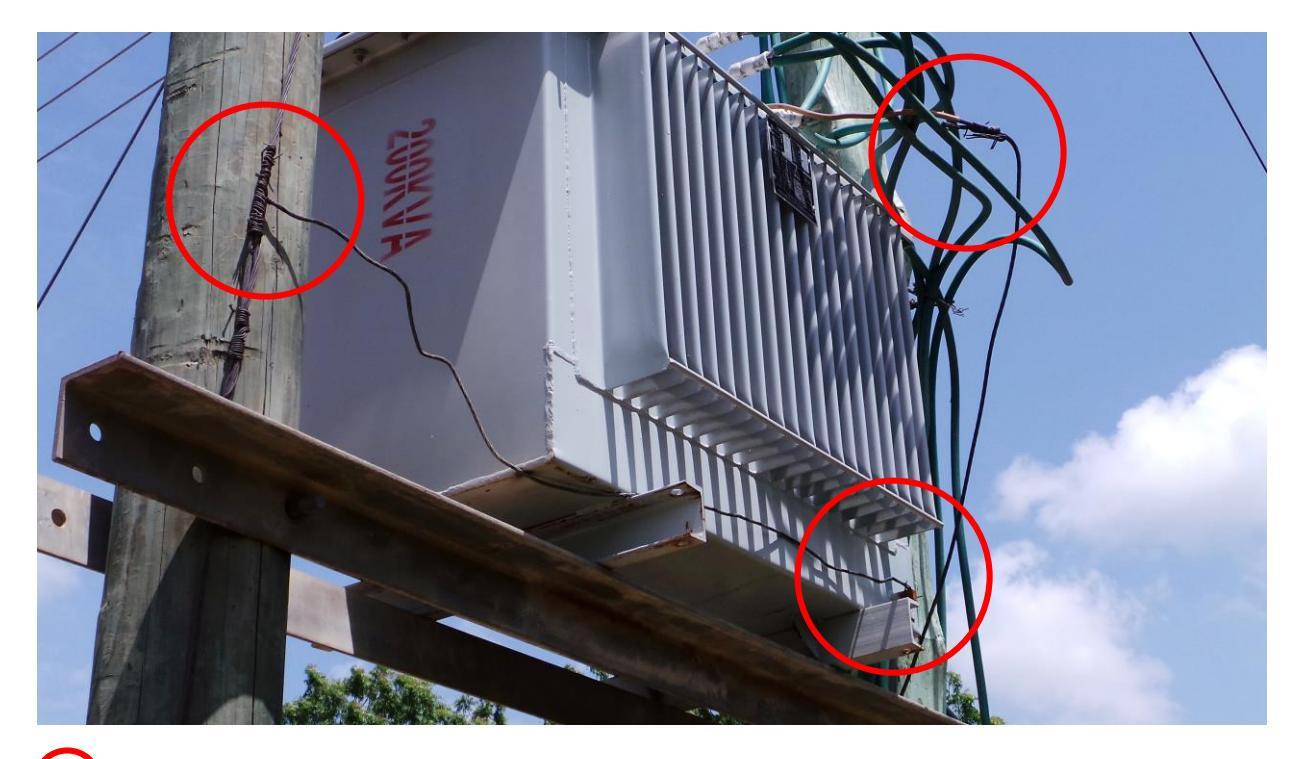
01 ECG – Feedline, Overhead Transformer:

01.01 The Voltage at the actual step of the Transformer is too high.....! High voltage will affect electrical and electronic systems all over the Hospital.

200 kVA, Δ 33 kV

L 1	\Leftrightarrow	Ν	= 252 V	116 Amps.
L 2	\Leftrightarrow	Ν	= 250 V	92 Amps
L 3	\Leftrightarrow	Ν	= 250 V	123 Amps

Grounding Resistance: 3.3Ω

Twisted wire, needs good cable connectors

The Voltage is too high. The ECG- Transformer must be stepped down to a tension of max. 235 V.

The Grounding Resistance must be below 1 Ω .

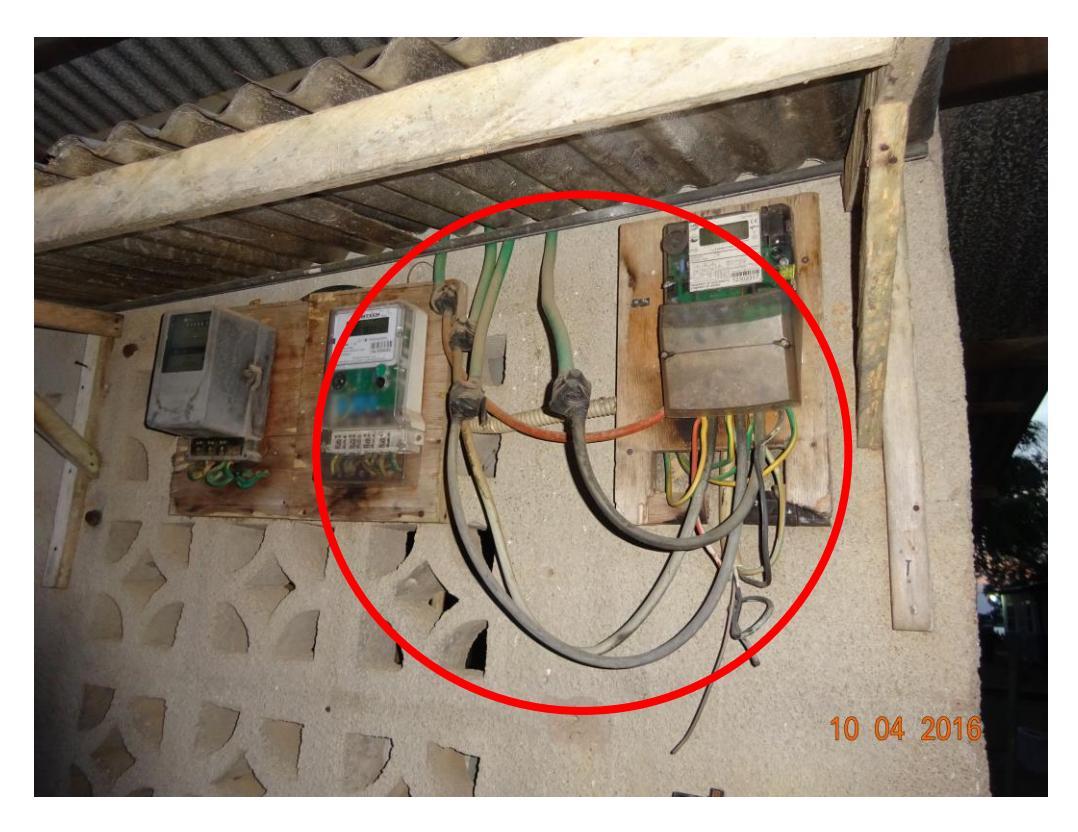
02 ECG- feeding Powerhouse:

02.01 The ECG- Grid main feeding line must be connected to an Incoming Fuse or switch before the connection to the ECG- meter.

02.02 Instead of single lead wires a cable with $4 \times 150 \text{ mm}^2$ would be requested.

02.03 In case of a fault, the incoming line must be able to switch off.

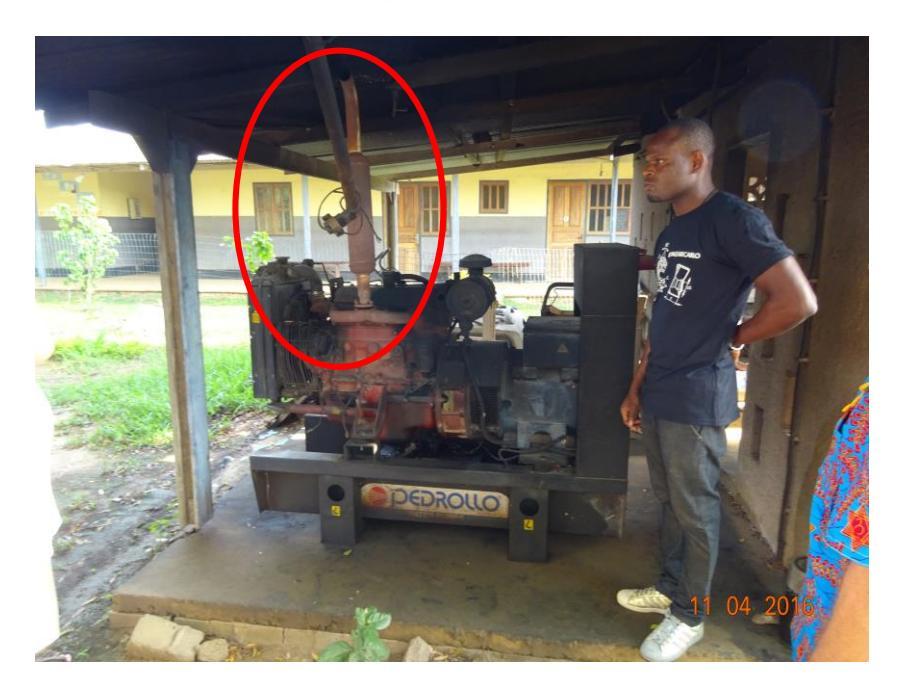
- 02.04 Whey there is no indirect metering with Currant converters 200/5 A.
- 02.05 The generator supply to the Theatre and the Dental clinic is in a very bad condition and needs a general replacement. (new cable)
- 02.06 Oil leakages, voltage fluctuations,
- 02.07 Exhaust must be guided outside the roof

- 02.08 The N- Lead must be hooked to the grounding system. (not available, must be build)
- 02.09 The connecting wires should be replaced with cable $5 \times 10 \text{ mm}^2$.
- 02.10 No reliable grounding system for the generator star point is available-A grounding system must be built with a grounding resistance less than 1 Ω .
- 02.11 Without a star point grounding, the human- and object safety is not guaranteed.
- 02.12 To provide a reliable emergency power supply, a new powerhouse like the one in the Catholic Hospital Battor must be build.
- 02.13 2 equal 200 kVA- Generator provide a redundant system. The planned 175 kVA- Generator can`t provide a development for the next ad least 10 Years.

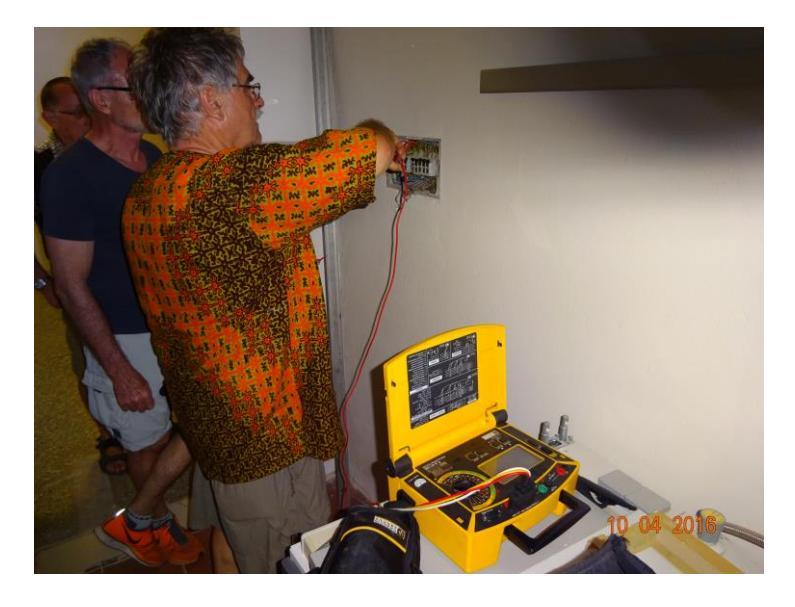
#03 Dental Clinic

- 03.01 All fuse boards need general overhauls. All wire connecting points must be divided to separate wire connector. (see sample GHST)
- 03.02 Some of the fuse groups are over fused and provide no safety. (Danger of fire) (1.5 mm² max. fuse 10 Amps, 2,5 mm² max. 16 Amps., 4 mm² max. 20 Amps., 6 mm² max. 25 Amps.....)
- 03.03 The main supply cable from the power house to the dental clinic must be replaced. (5 x 16 mm²)
- 03.04 All wall sockets must be connected with a separate lead (yellow- green) to the ground.
- 03.05 All metallic table and others must be connected to the ground. (min. size cable 2.5 mm² yellow- green)

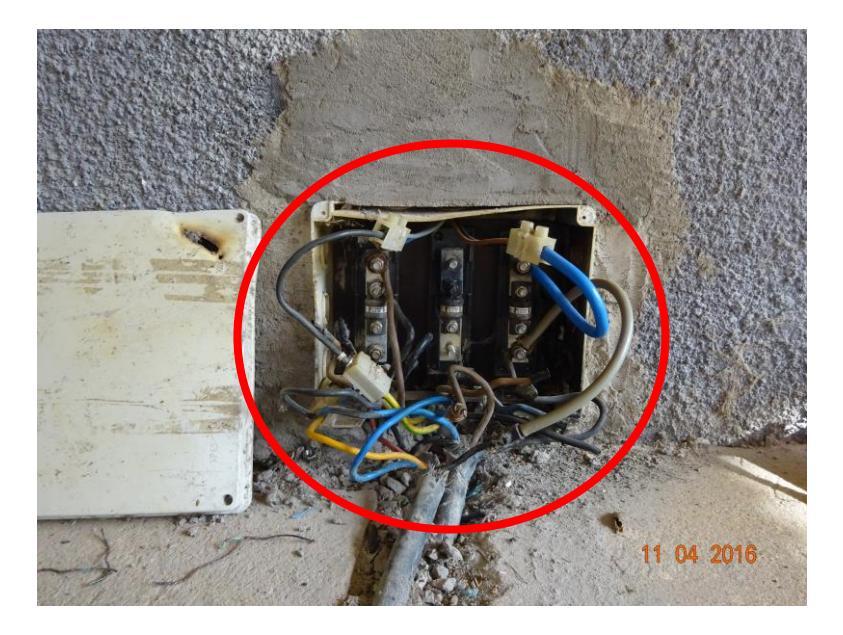
#04 Theatre

- 04.01 The whole electrical installation at the theatre is in a very bad condition and unsafe.
- 04.02 The main supply line from Powerhouse must be replaced. Size $5 \times 16 \text{ mm}^2$.
- 04.03 The junction box for the incoming cable is located on a dangerous place. The box must be fixed 1.5 m above the floor Open connections, twisted cable connections, no way to identify the leads, not covered...

- 04.04 All fuse boxes must be done as sample GSHT to prevent electrical shocks and fire.
- 04.05 Theatre, ordination rooms, operating beds and tables are listed in the highest electrical security standard and must be hocked to a separate Potential equalisation system and RCD- protection. For that contact HTU to get instruction.
- 04.06 An adequate UPS- System must be installed to bridge the blackout time in case of a blackout. All life support systems, lights, air conditioner must be able to run them for at least 1 hour as an autonomy System. (15 20 kVA)
- 04.06 The central air conditioner needs a general overhaul. New Air filter, faulty electrical control board, cleaning air channels....

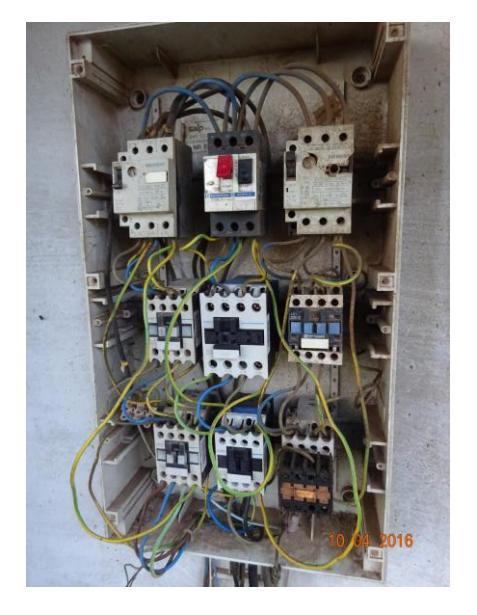
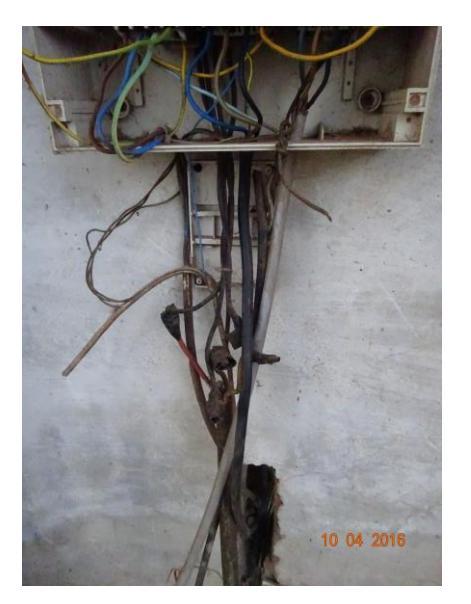
05 Hospital Main water supply

- 05.01 The Electrical connection is faulty. A new cable from the power house to the water pumping station must be installed, size $5 \times 10 \text{ mm}^2$.
- 05.02 The pump control board is in a horrible condition. Wrong coloured and flying wires, twisted wire connection, no adequate fuse, no RCD...!!
- 05.03 The pump control board is open and is affected from dust and humidity, the installation must be placed in a dust- and waterproof housing.
- 05.04 An useful Water filtering system should be installed to prevent clogging the pipes.

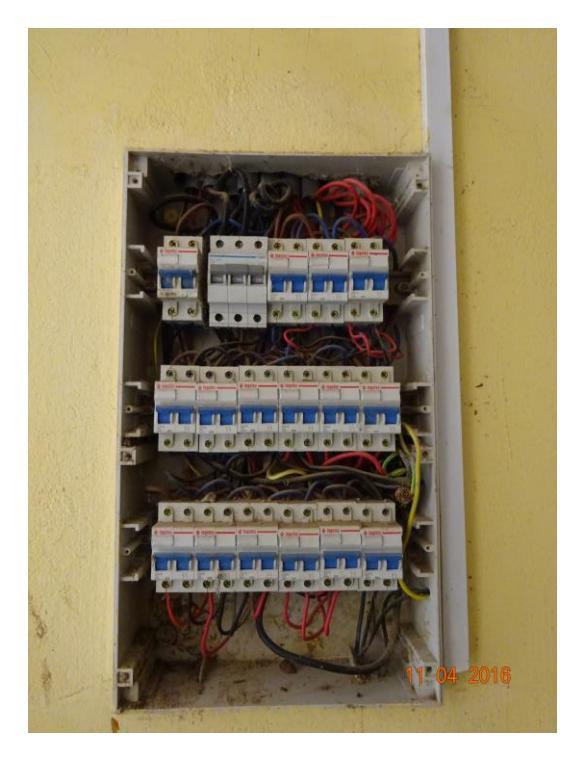
06 Administration Block

- 06.01 The ECG incoming line is connected direct to the fuse board. A main control switch must be installed. To prevent and protect all electronic devices from overvoltage and lightning a solid grounded surge must be installed.
- 06.02 Most of the electrical circuits are over fused. Replace the wrong fuses according the outgoing size of the wires. (see 03.02) .
- 06.03 To hock the administration block to the emergency power supply, a cable from Powerhouse should be laid. Size 5 x 16 mm² .
- 06.04 All wall sockets must be checked. Most of them are not connected to the Ground.

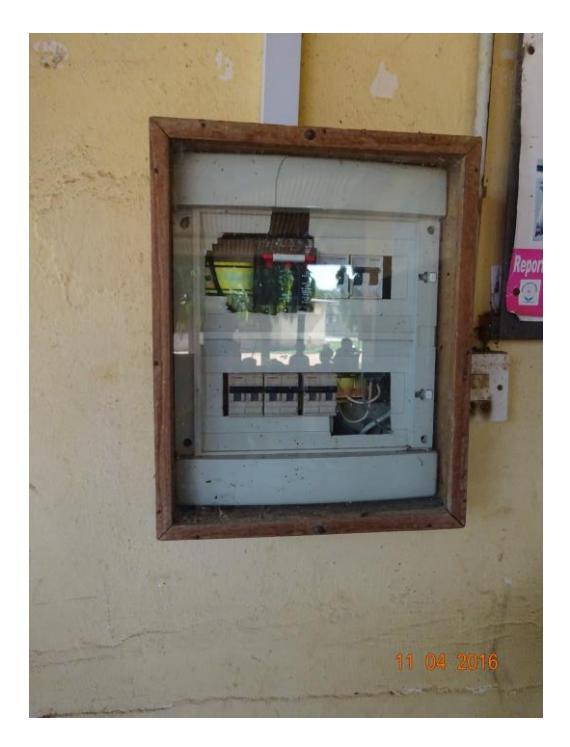
#07 Maternity

- 07.01 The fuse board must be done like the GSHT sample. Some of the outgoing lines are over fused. See 03.02
- 07.02 The fuse board cover must be fixed proper to prevent dust and insects to enter.
- 07.03 To hook the Maternity block to the emergency power supply, a separate cable connection to the power house should be done. Size 5 x 10 mm^2 .
